Manhole Inspection Summary

Manhole # S35K1_001MH

Insp Date: **3/26/08 7:41 AM**

Location Address: **3001 S Hanover St.(Harbor Eyes Optical Inc.)**

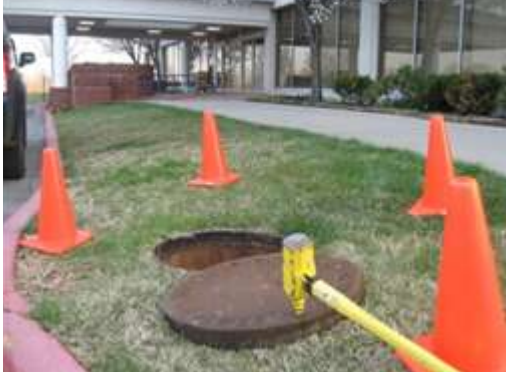
Location View

3001 S Hanover St.

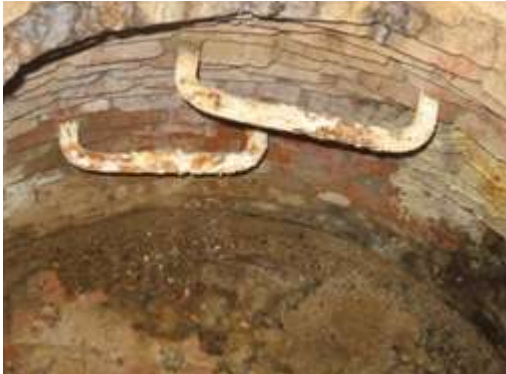
Steps Count: **2** Missing: **0** ☒ **Corroded**

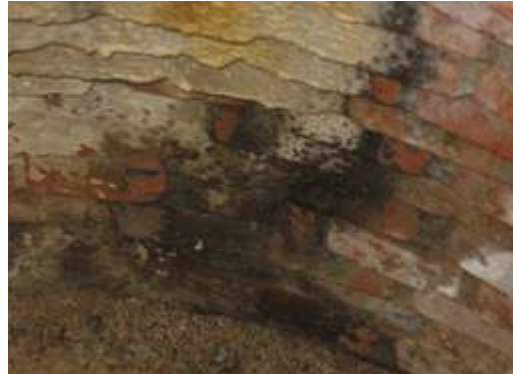
Defect 1

Infiltration

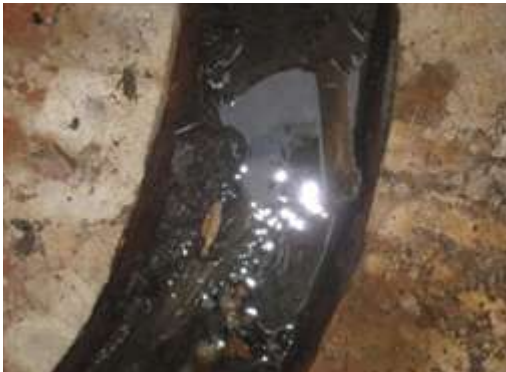
Defect 2

Debris in Channel

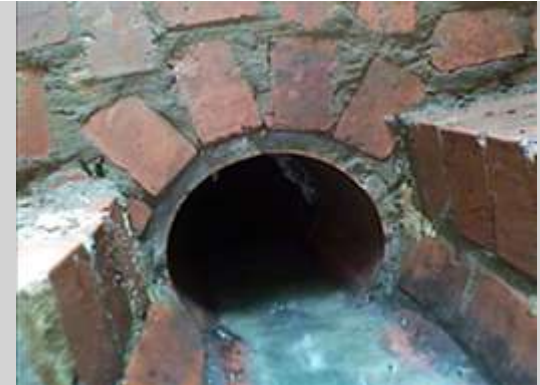
12 O'Clock Outflow

8 in. Circular Gravity Sewer
Pipe Out @ 12 O'Clock

Pipe Height: **8.4** (in.) Rod and Bar (Angled)
Pipe Material: **Clay** ☐ Pipe Lined
Invert Depth: **6.61** (ft.) Flow Characteristics: **Slow**
Deposits: ☒ None ☐ Mud ☐ Sludge ☐ Debris ☐ Grease
Silt Depth: (in.) Deposits Extent:
Infiltration: **None** Pipe Seal Cond: **Sound**

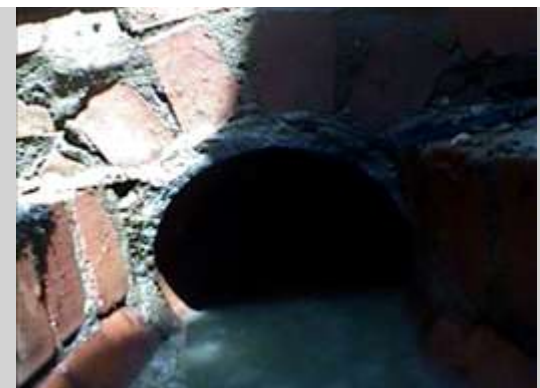
8 O'Clock Inflow

8 in. Circular Gravity Sewer
Pipe In @ 8 O'Clock

Pipe Height: **8.4** (in.) Rod and Bar (Angled)
Pipe Material: **Clay** ☐ Pipe Lined
Invert Depth: **6.62** (ft.) Flow Characteristics: **Slow**
Deposits: ☒ None ☐ Mud ☐ Sludge ☐ Debris ☐ Grease
Silt Depth: (in.) Deposits Extent:
Infiltration: **None** Pipe Seal Cond: **Sound**
